**Draft Report  
Project No. 60251**

**Volume 1 of 5  
Remedial Investigation Report  
ACS NPL Site  
Griffith, Indiana**

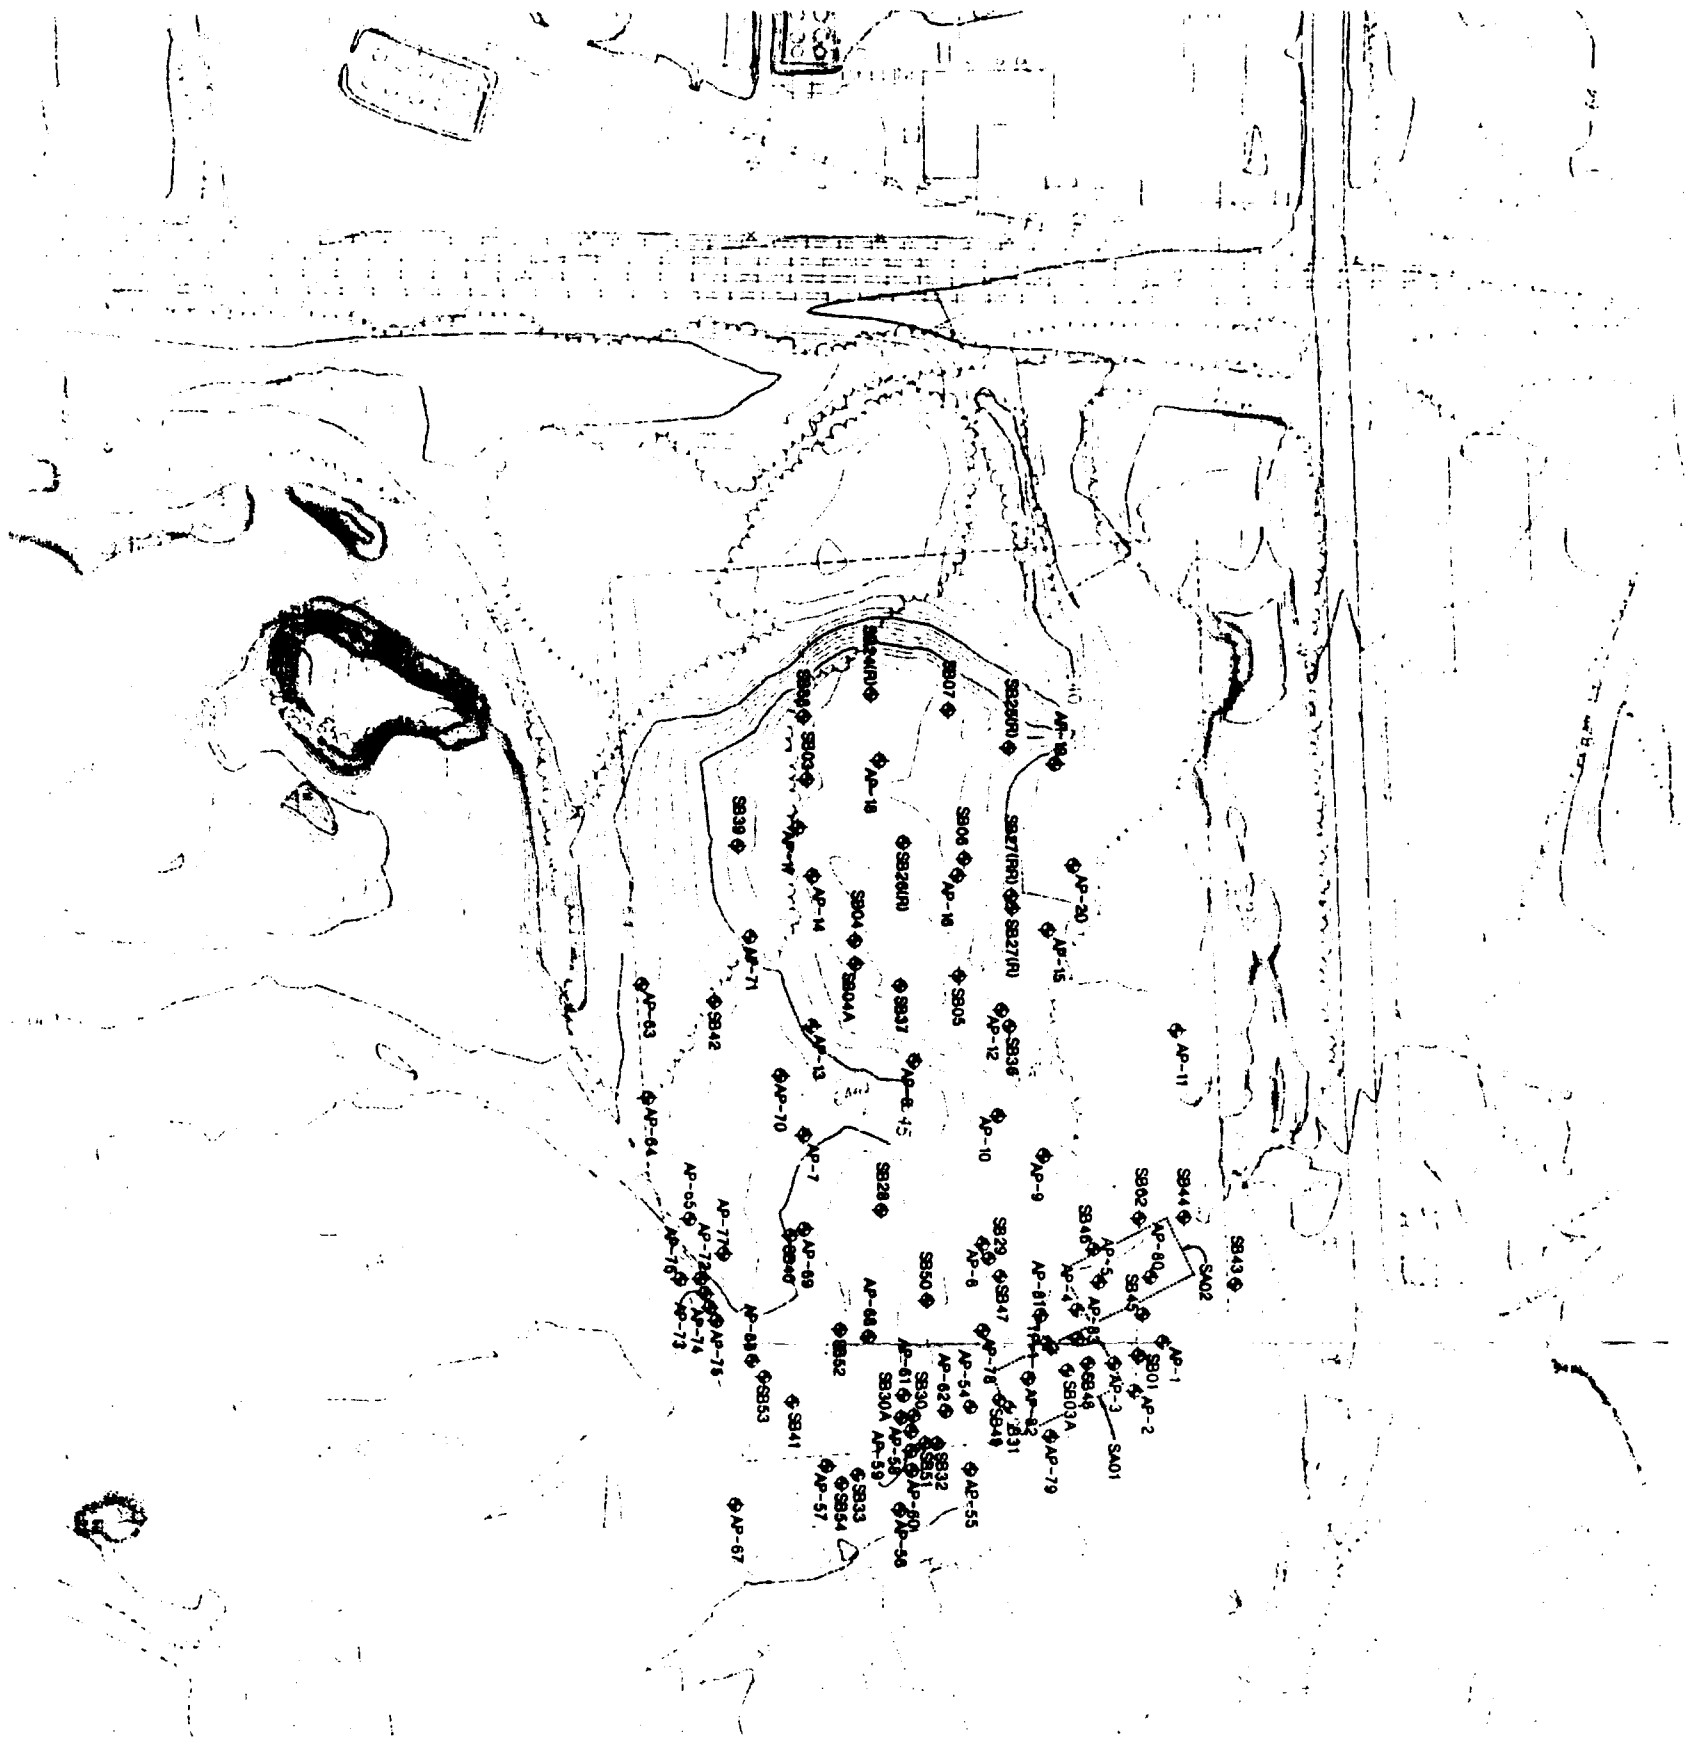
FIGURE 2-1

- GEOPHYSICS INVESTIGATION AREA
- SB-01 SOIL BORING LOCATION & NUMBER
- AP-01 AUGER PROBE LOCATION & NUMBER
- TP-1 TEST PIT LOCATION & NUMBER
- SA-01 SOIL AREA LOCATION & NUMBER

Seventy-three soil borings were drilled and sampled during the course of the RI. Locations of these borings are illustrated in Figures 2-1 and 2-2. Boring logs are contained in Appendix D.

The investigation was conducted by first making single, 10-foot deep auger probes 100 feet north, 100 feet west, and 100 feet south of P-38. When no waste was found floating on the water table at those locations, the distances were halved, and auger probes were made 50 feet in each of the three directions from P-38. These borings again showed no accumulation of floating waste, so the distance was halved again to 20 feet. The auger probe locations (AP-45 through AP-53) are shown on Figure 2-1.

4.5.2.1 Physical Testing and Documentation. Boring logs were kept in the field by the supervising geologist at all soil boring and monitoring well locations. The log for each borehole is contained in Appendix D and locations are identified on Figures 2-1, 2-2 and 2-3.

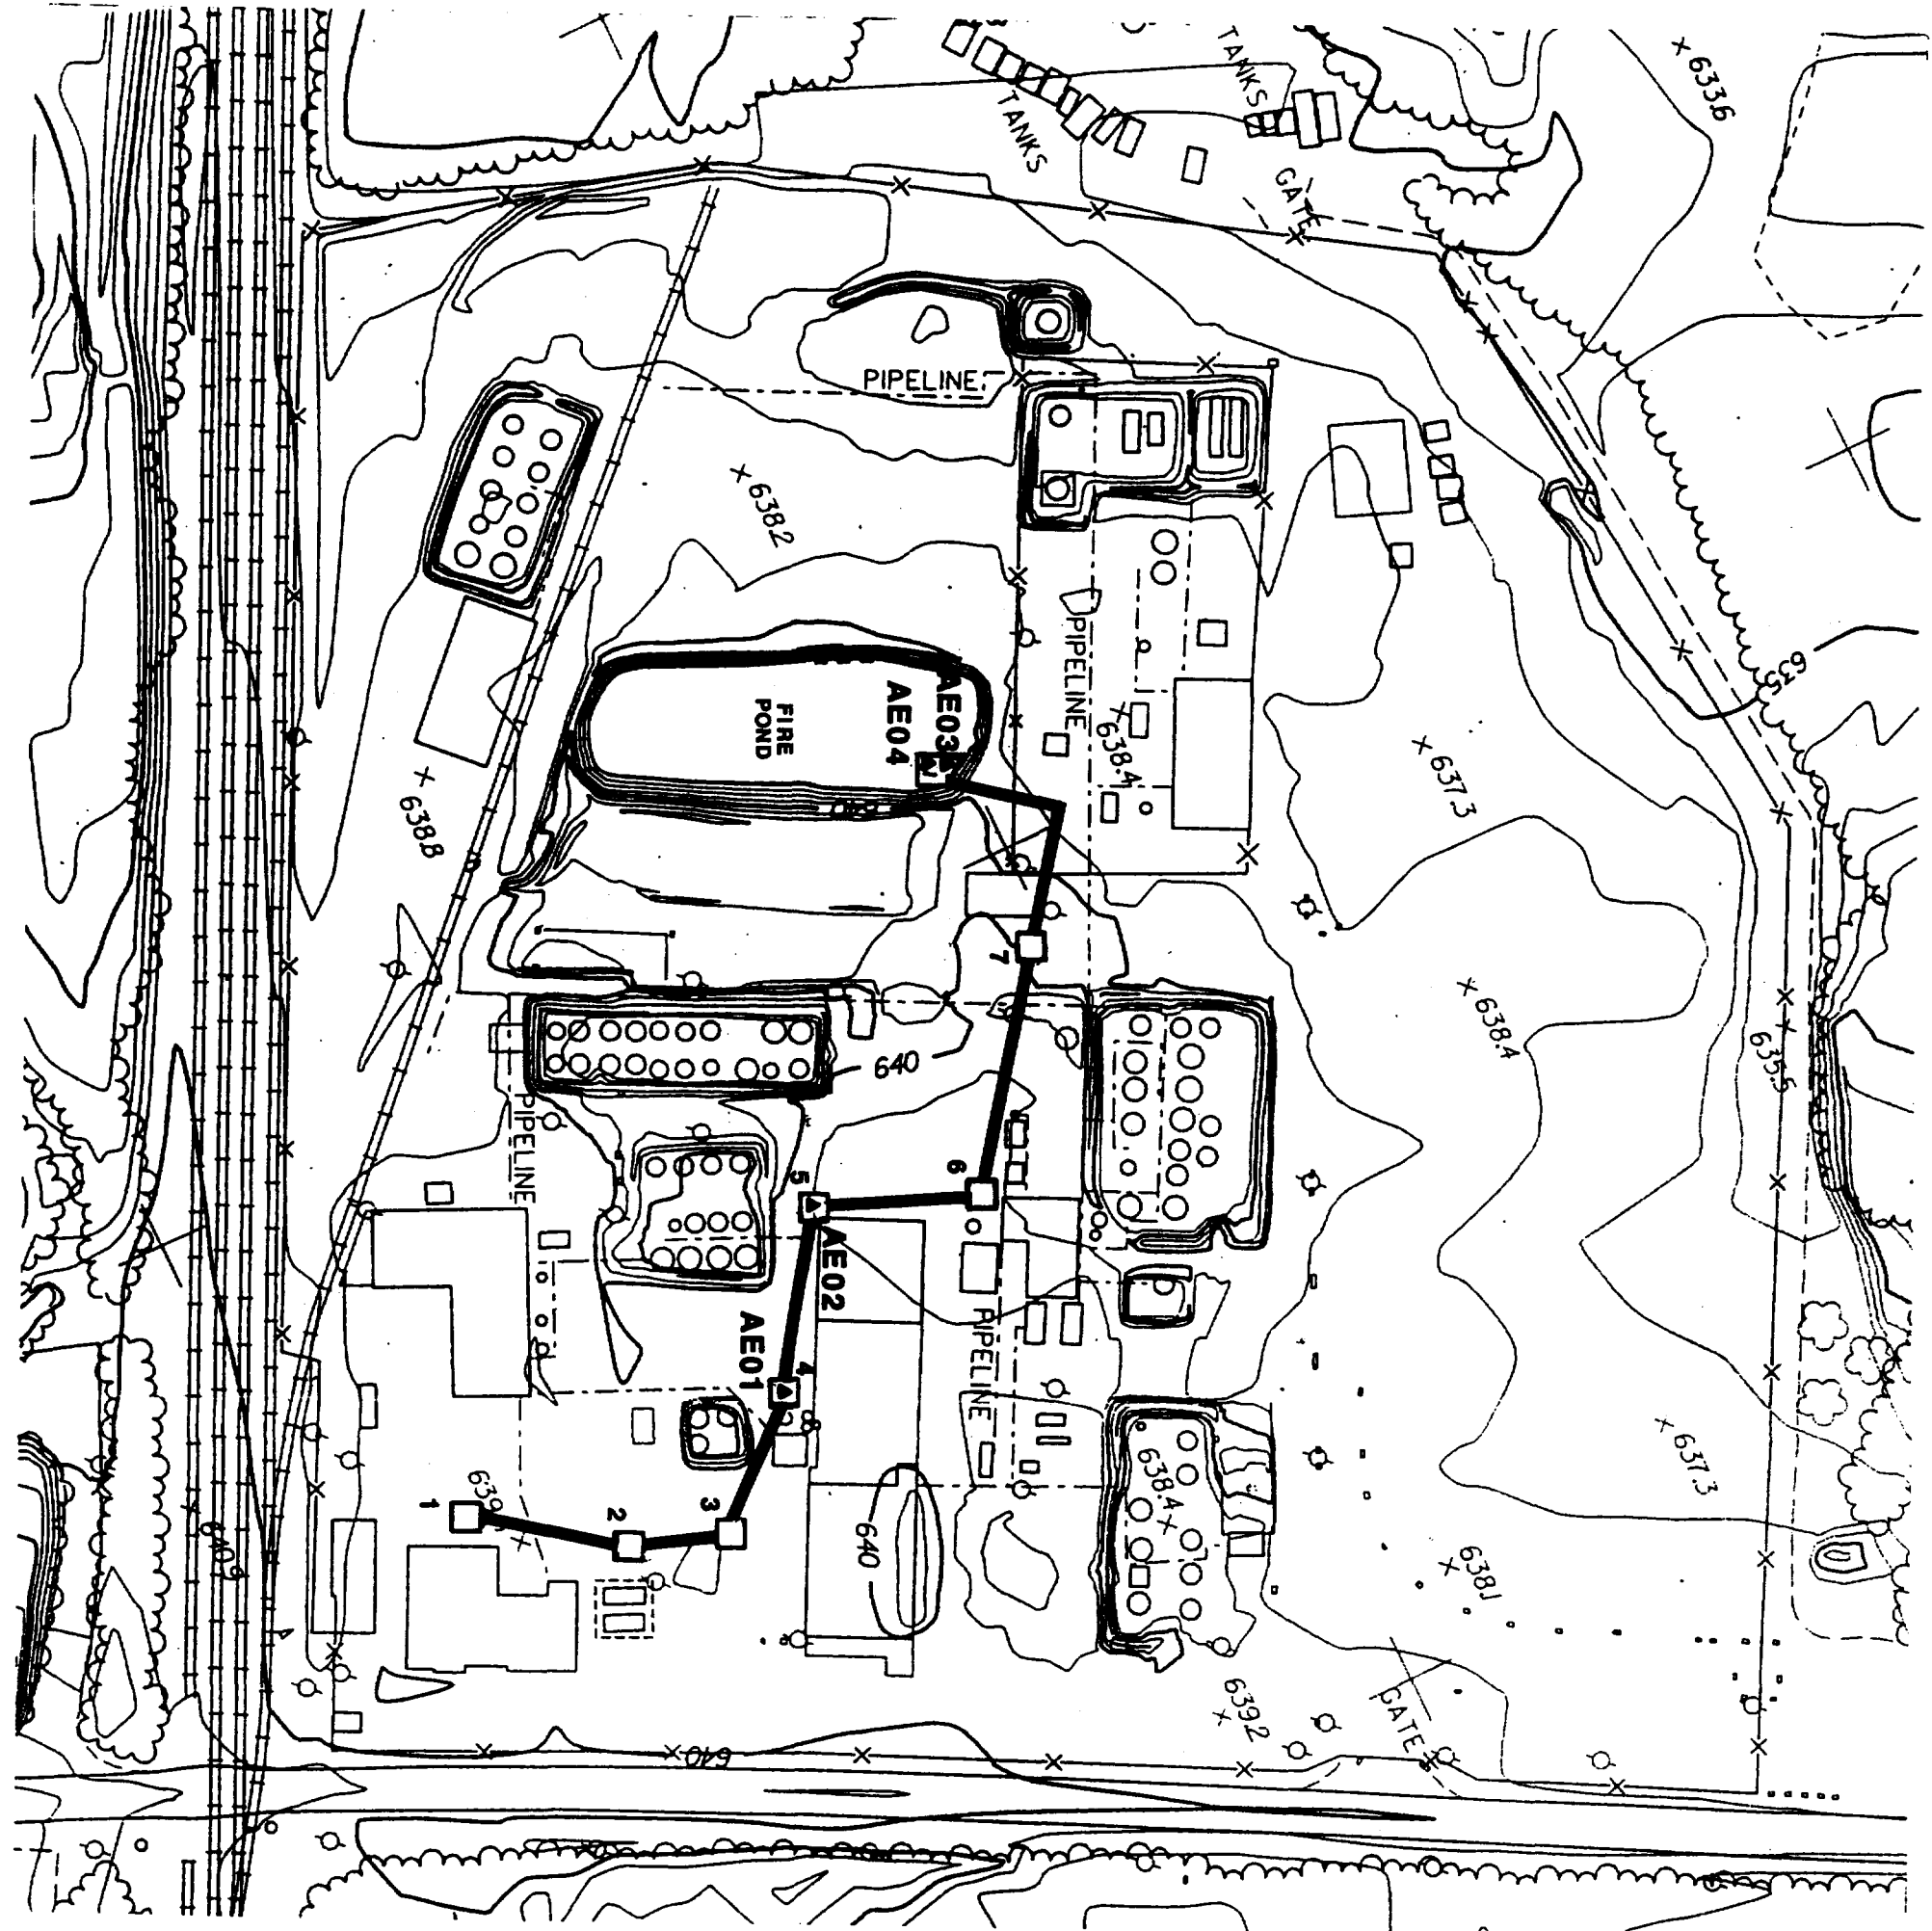
FIGURE 4-20

- LEGEND**
- STORM SEWER
  - CATCH BASIN
  - EFFLUENT SAMPLING LOCATION

- NOTES**
1. AT SAMPLING LOCATION AE01 SAMPLE WAS COLLECTED FROM 7' OF WATER FOUND IN CATCH BASIN.
  2. AT SAMPLE LOCATION AE02 SAMPLE WAS COLLECTED FROM 5.5' OF WATER FOUND IN CATCH BASIN.
  3. AT SAMPLE LOCATION AE03, SAMPLE WAS COLLECTED BY SKIMMING WATER OFF THE SURFACE.
  4. AT SAMPLE LOCATION AE04 SAMPLE WAS COLLECTED FROM THE BOTTOM OF CATCH BASIN (16' DEEP).
  5. EFFLUENT SAMPLING WAS CONDUCTED BY WARZYN ENGINEERING INC. ON NOVEMBER 15, 1989.
  6. INITIAL BASE MAP WAS DEVELOPED FOR CAMP DRESSER & MCKEE INC. ON NOVEMBER 8, 1985. MAP HAS BEEN UPDATED FROM AN AERIAL PHOTOGRAPH OF THE SITE FLOWN ON NOVEMBER 3, 1989 BY GEONEX CHICAGO AERIAL SURVEY, INC. THE BASE MAP WAS UPDATED BASED ON THE AERIAL PHOTOGRAPH BY GEONEX.

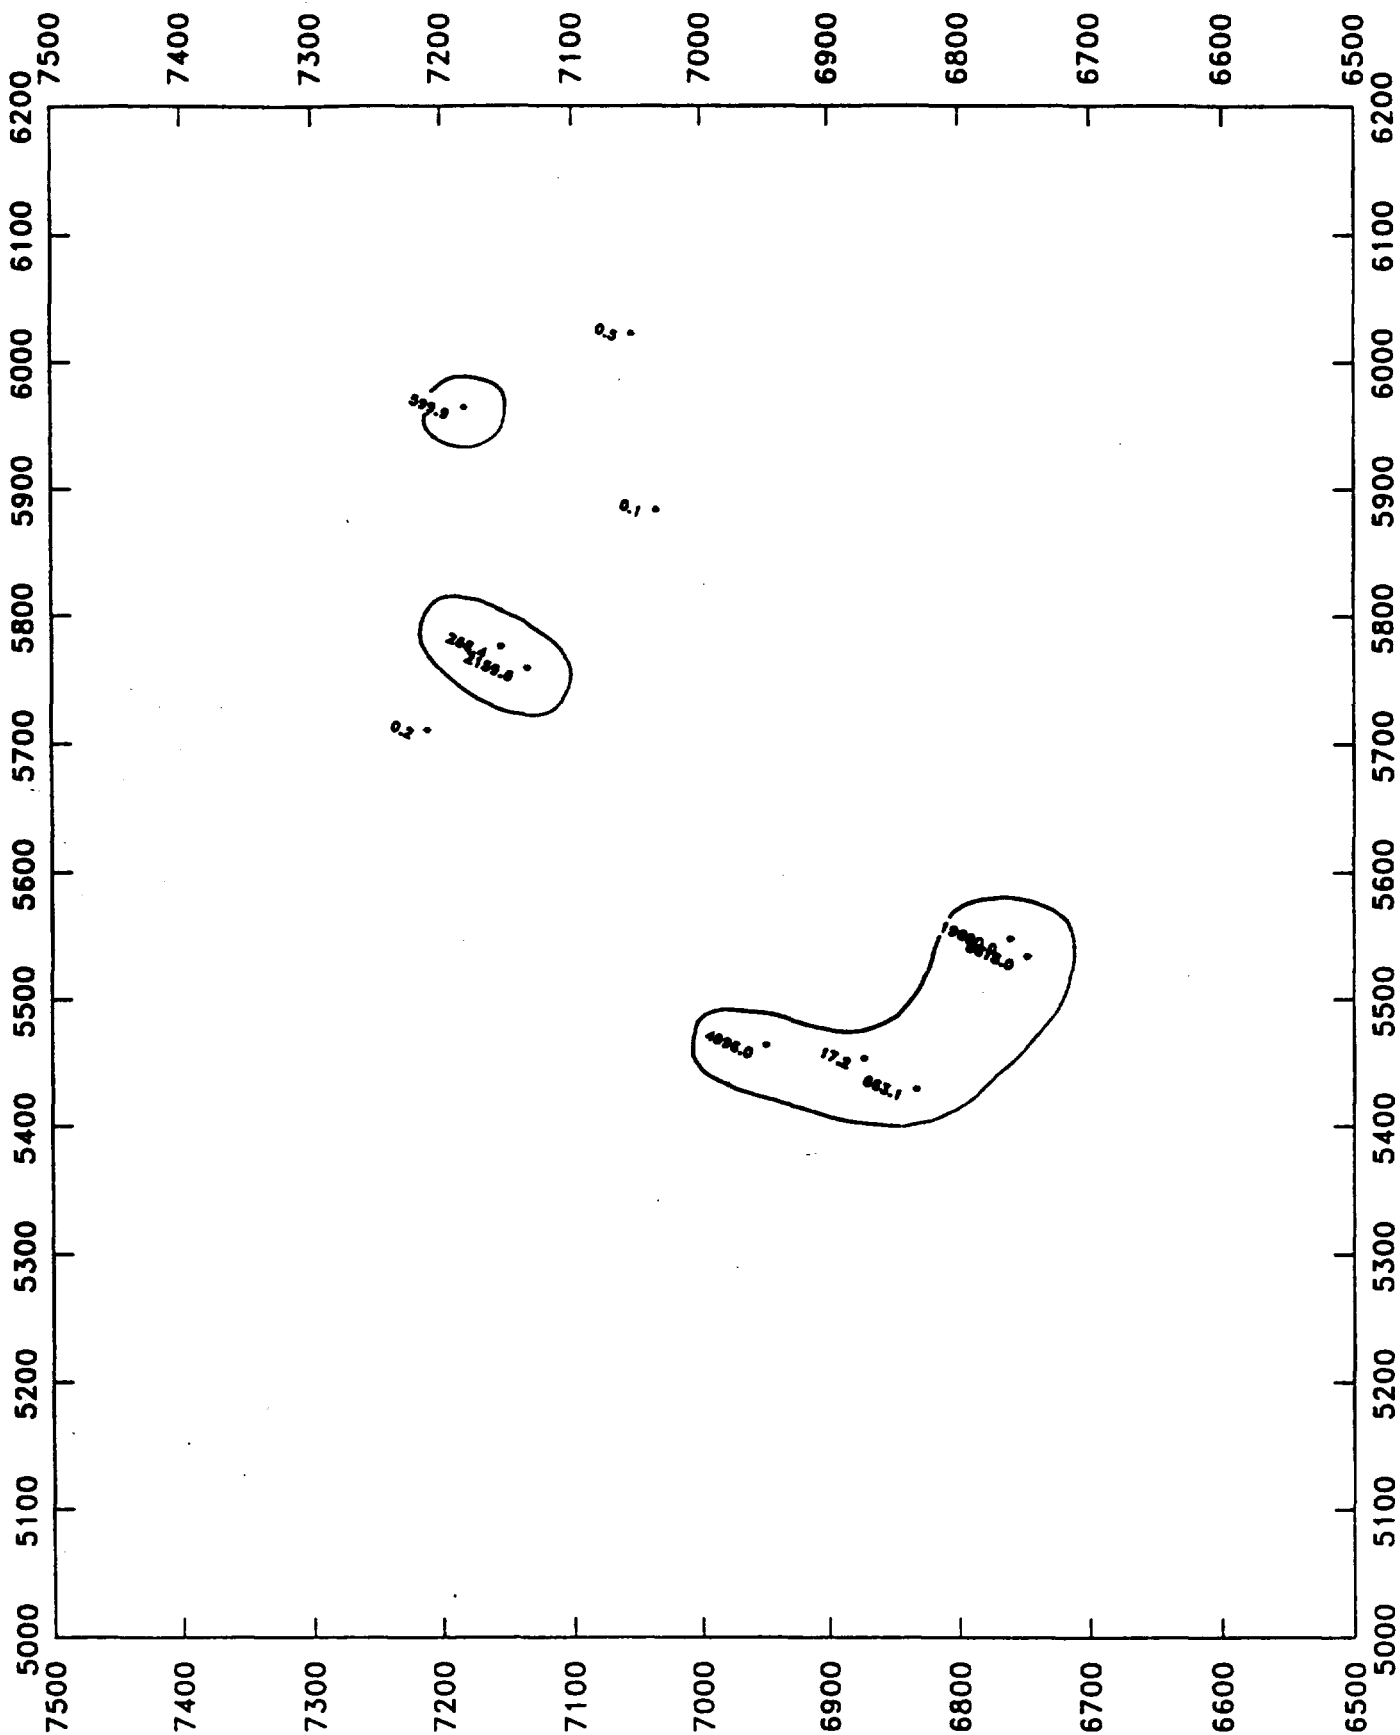
Figure 5-6b Approximate Extent of Total Volatile Wastes (> 1 ppm), On-Site Areas (4-7 feet below surface). Posted Values are in ppm (mg/kg).

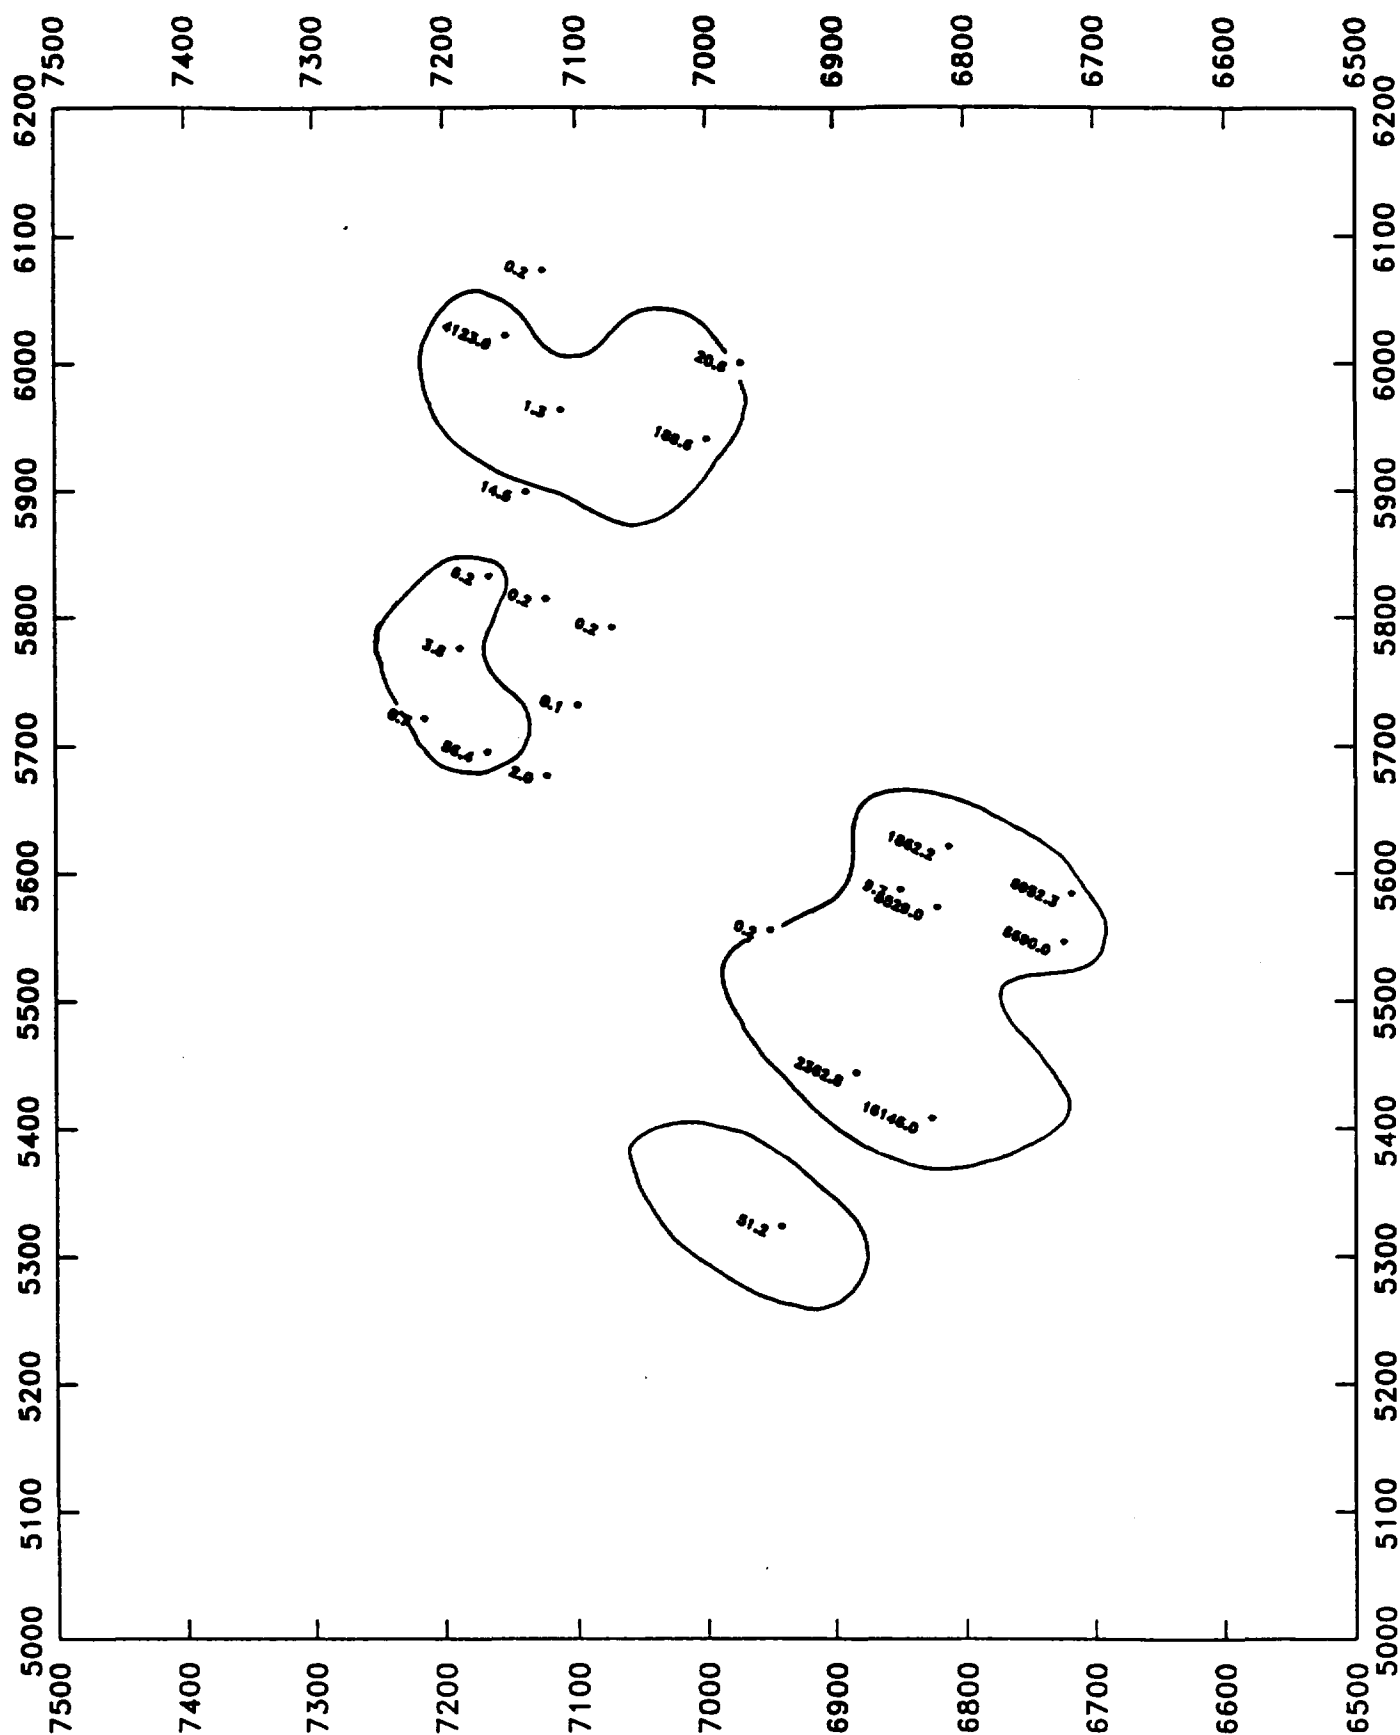
Figure 5-6c Approximate Extent of Total Volatile Wastes (> 1 ppm), On-Site Areas 7-9 feet below surface). Posted Values are in ppm (mg/kg).

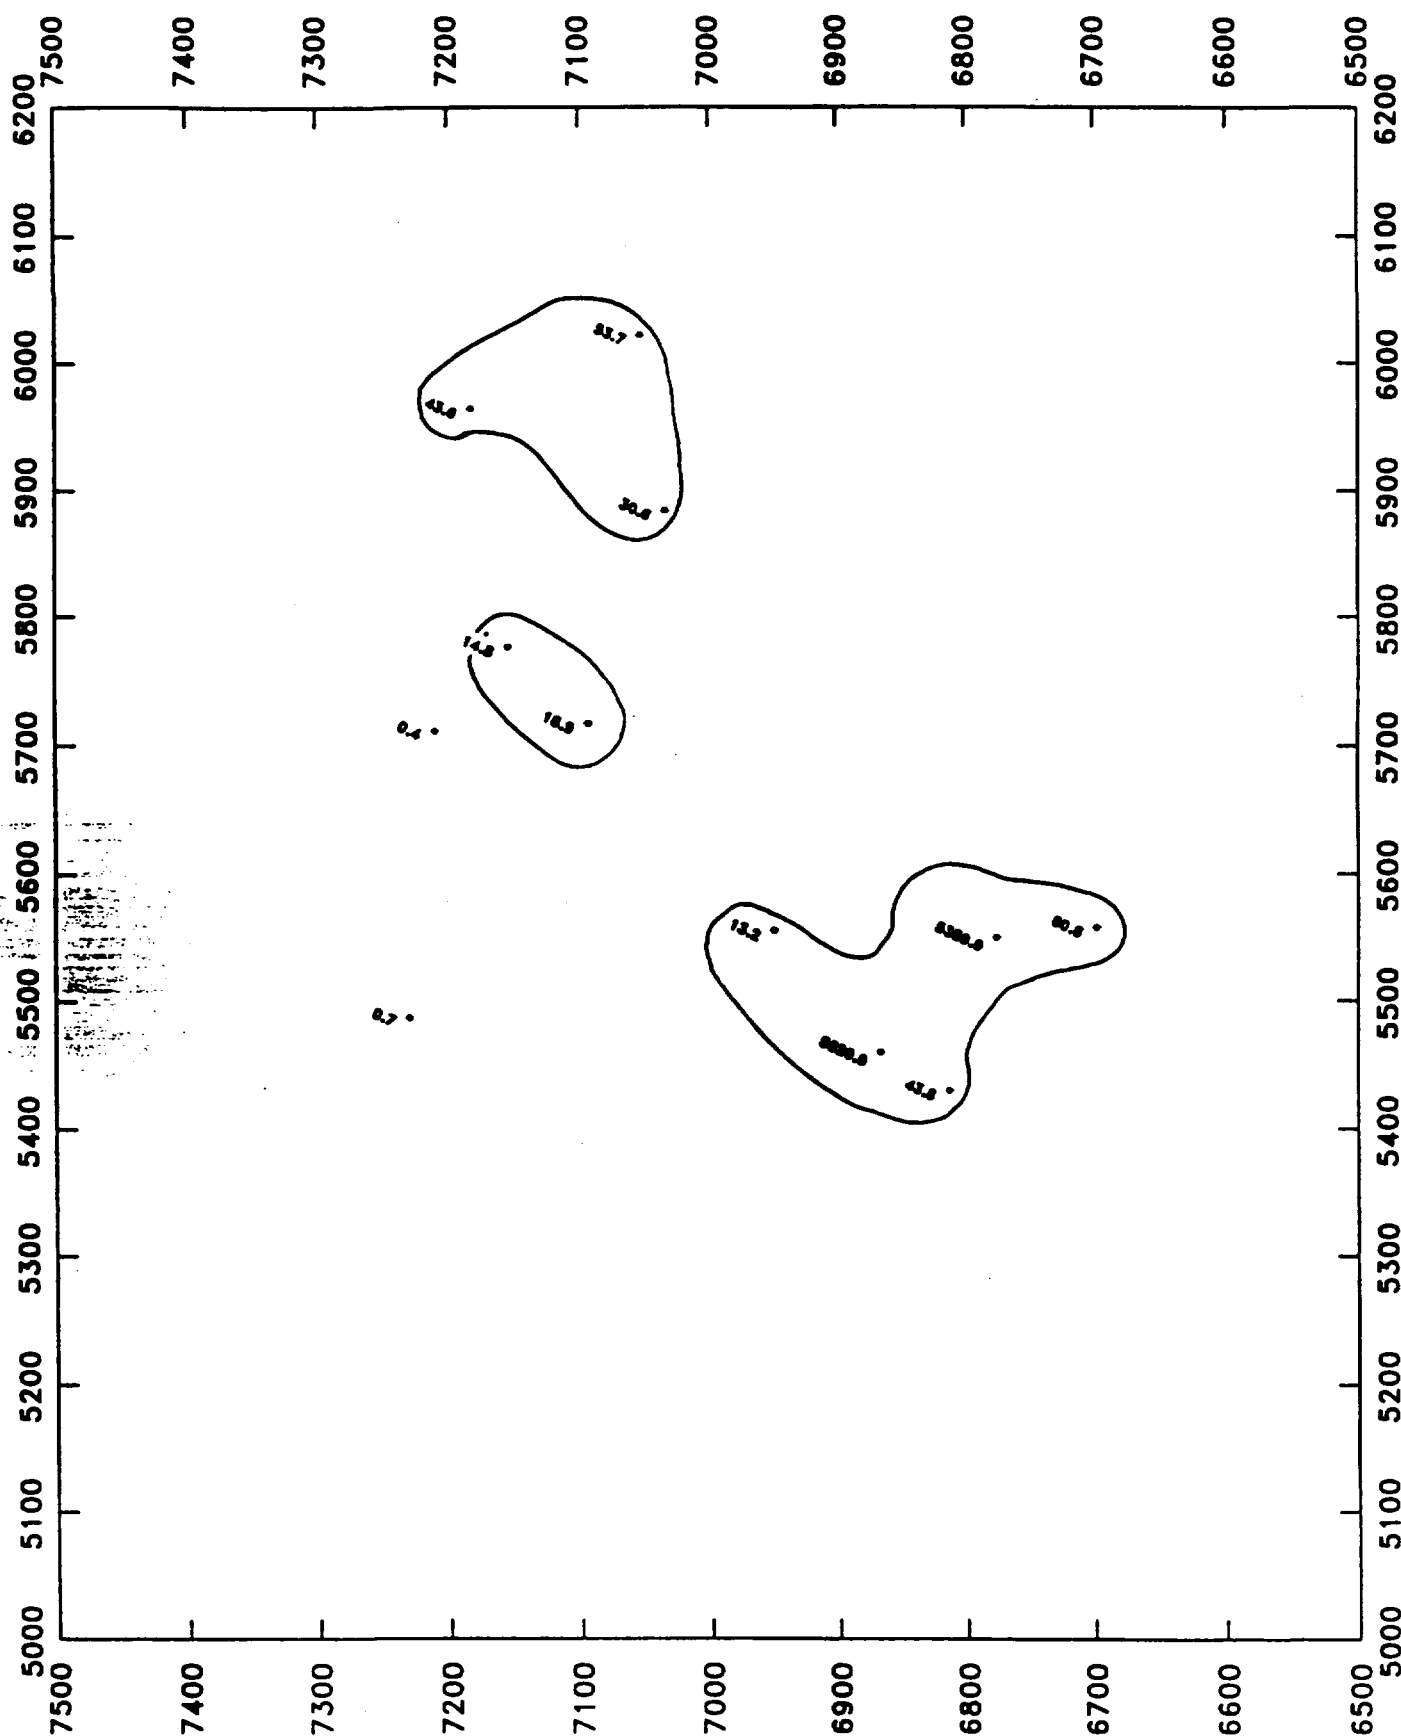
Figure 5-6d Approximate Extent of Total Volatile Wastes (> 1 ppm), On-Site Areas (9-14 feet below surface). Posted Values are in ppm (mg/kg).

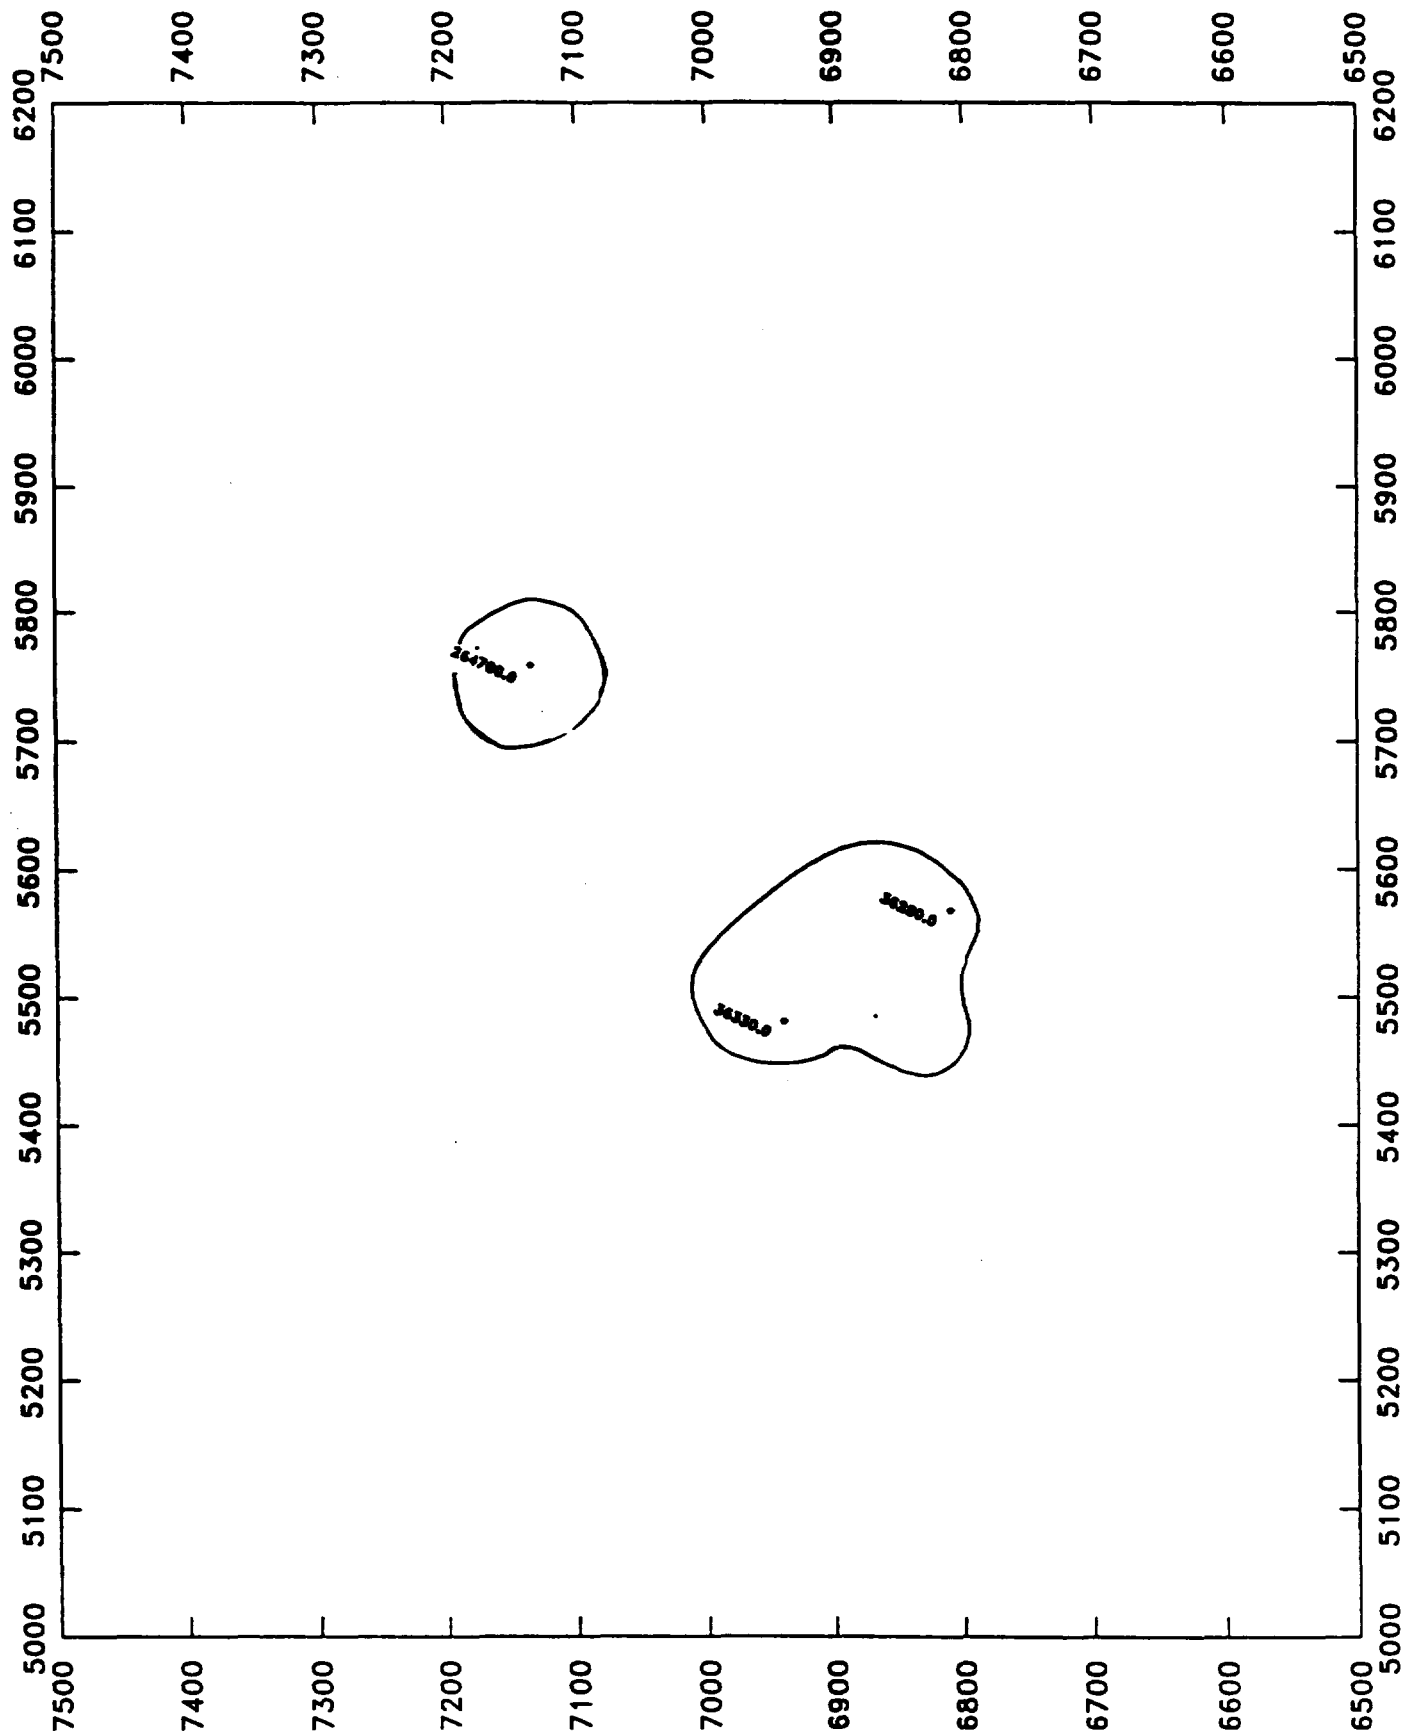
Figure 5-6a Approximate Extent of Total Volatile Wastes (> 1 ppm), On-Site Areas (1-4 feet below surface). Posted Values are in ppm (mg/kg).

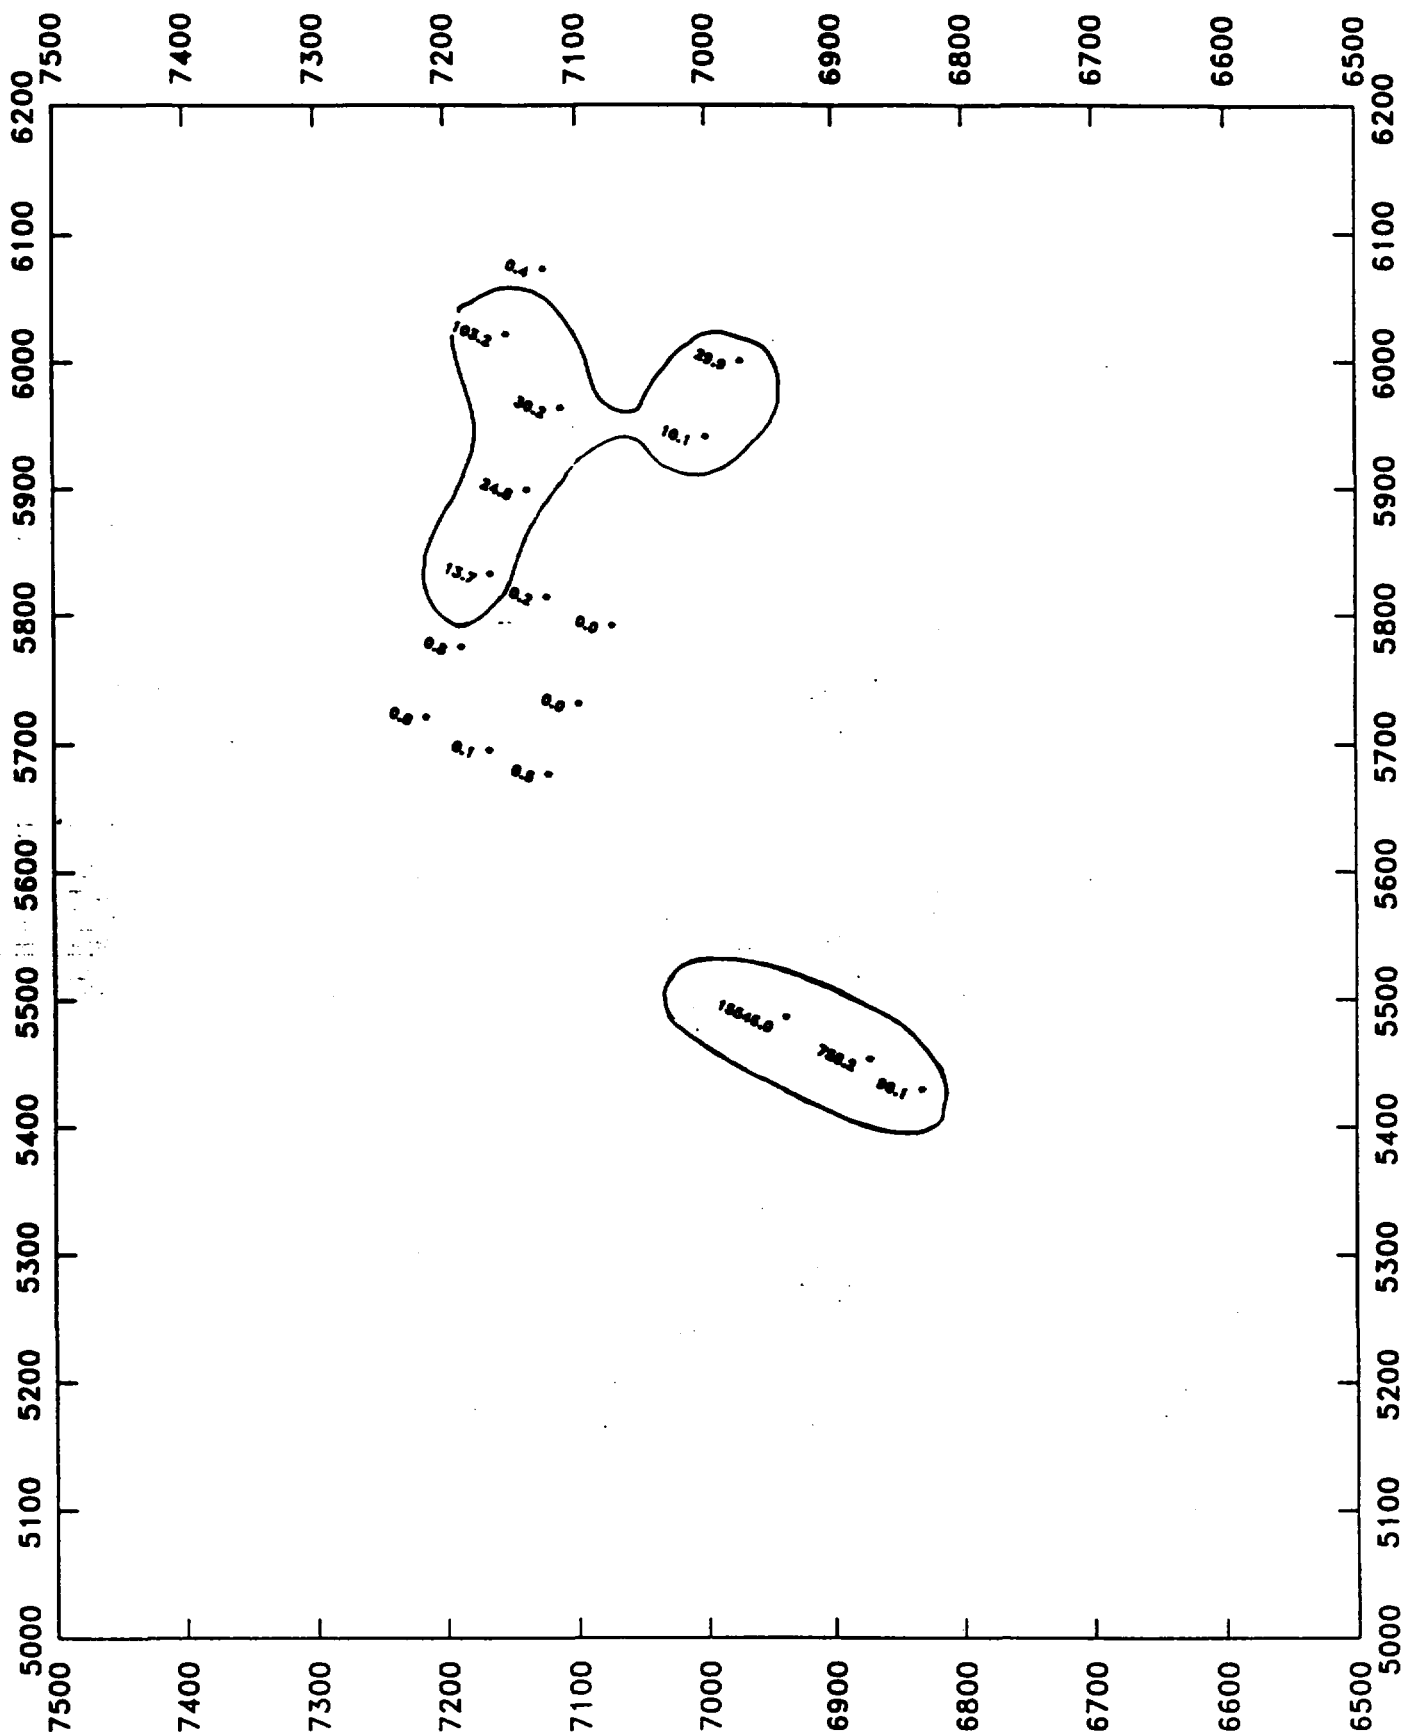
Figure 5-6e Approximate Extent of Total Volatile Wastes (> 1 ppm), On-Site Areas (14-19 feet below surface). Posted Values are in ppm (mg/kg).

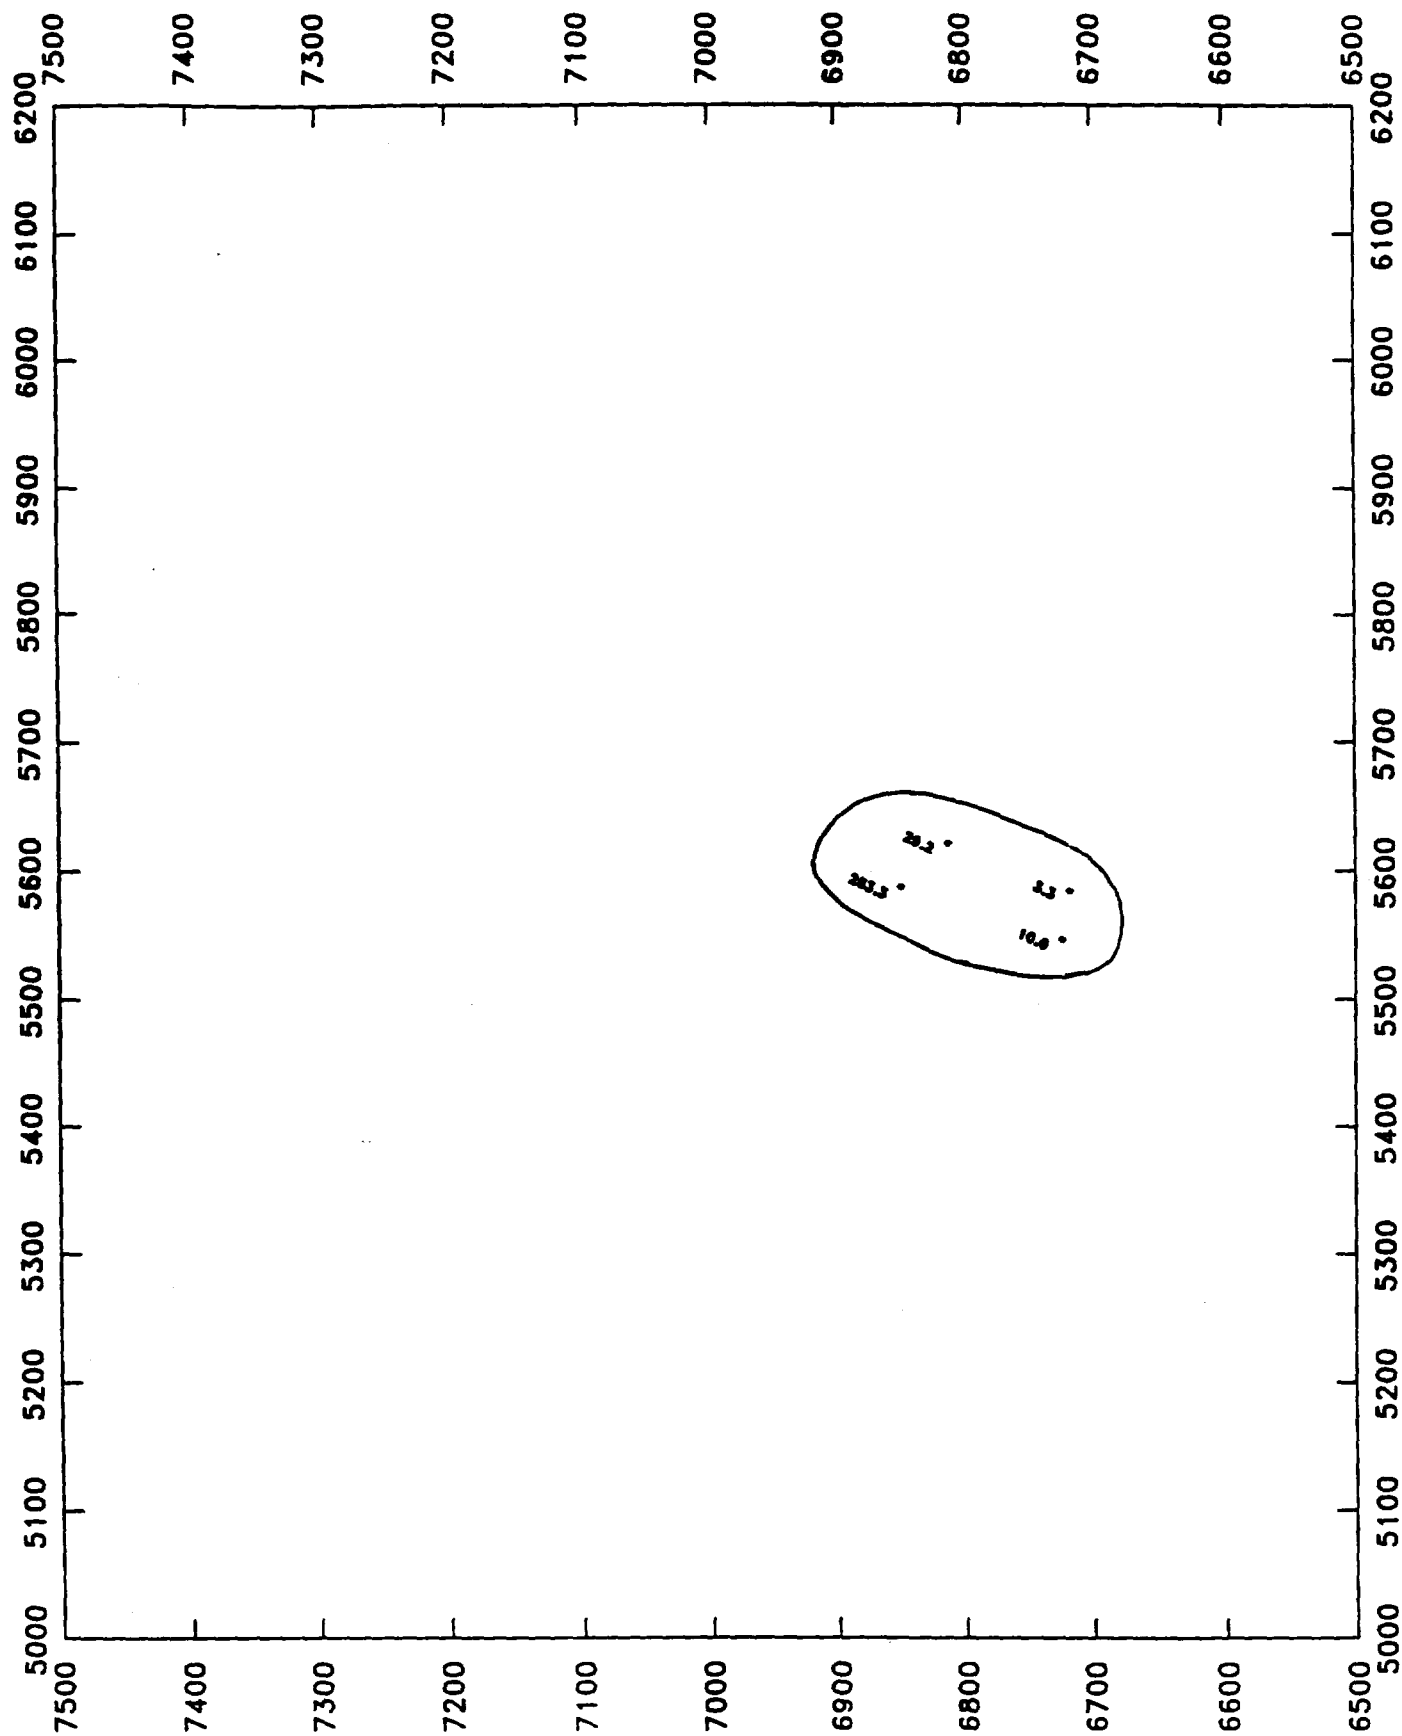
Figure 5-6f Approximate Extent of Total Volatile Wastes (> 1 ppm), On-Site Areas 19-24 feet below surface). Posted Values are in ppm (mg/kg).
